# DELTA Test Report

## Climatic and mechanical testing of Handset PP5 Series

### Performed for KIRK telecom A/S

Project no.: E501508-2

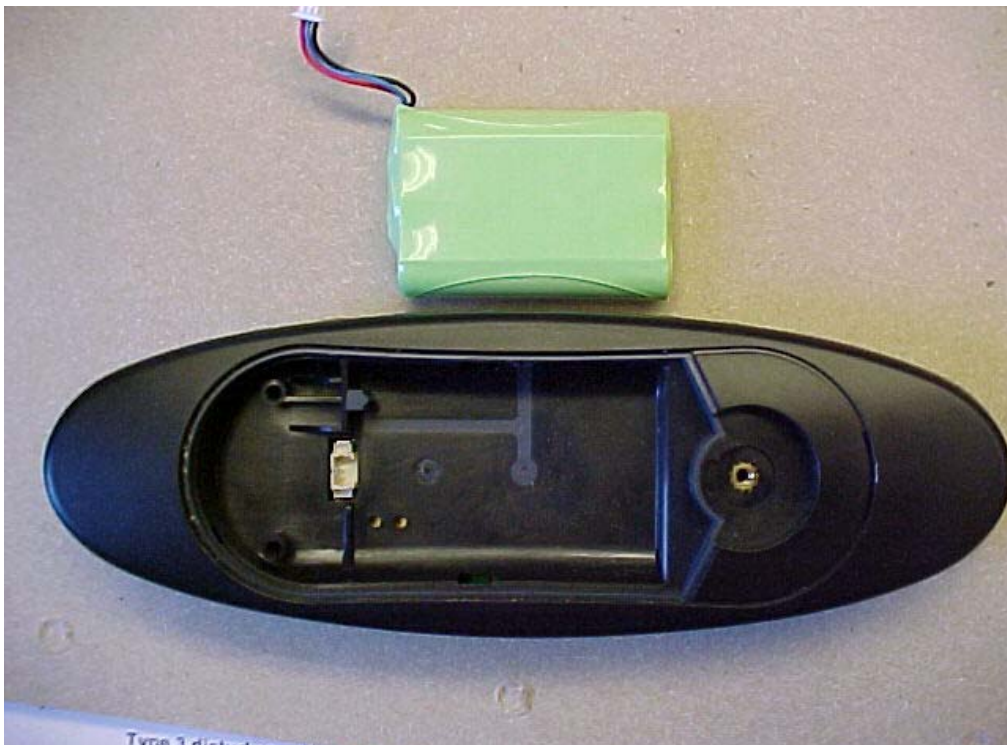
No corrosion attack was observed after the exposure.

PHOTO 4. Visual inspection after salt mist testing (no salt deposits inside).

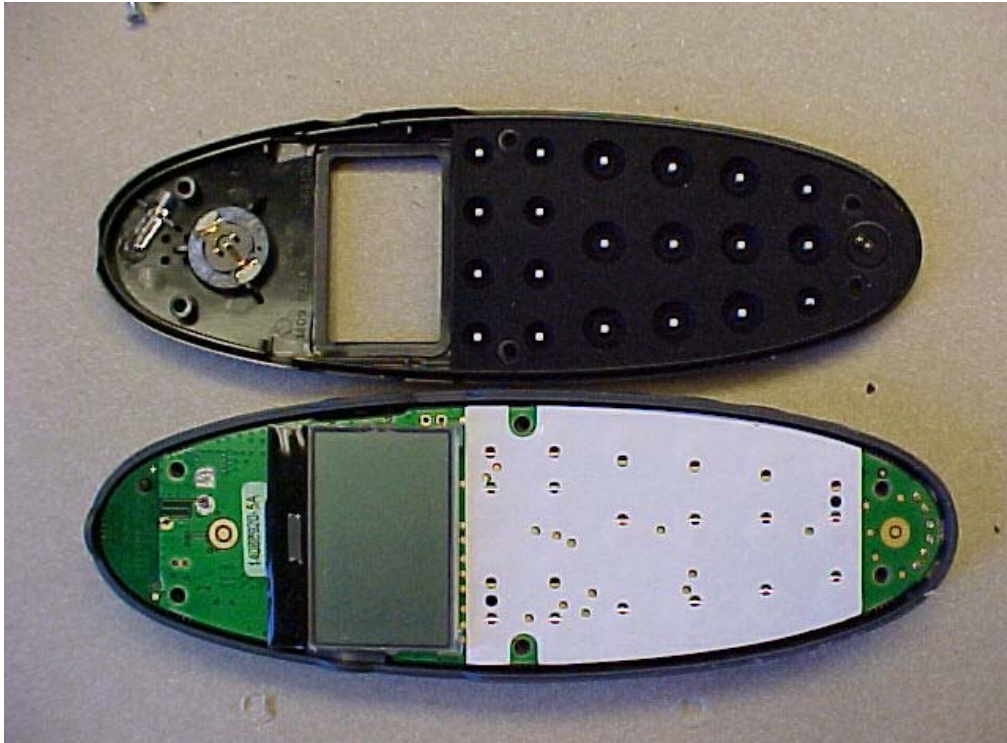
PHOTO 5. Visual inspection after salt mist testing (no salt deposits inside).

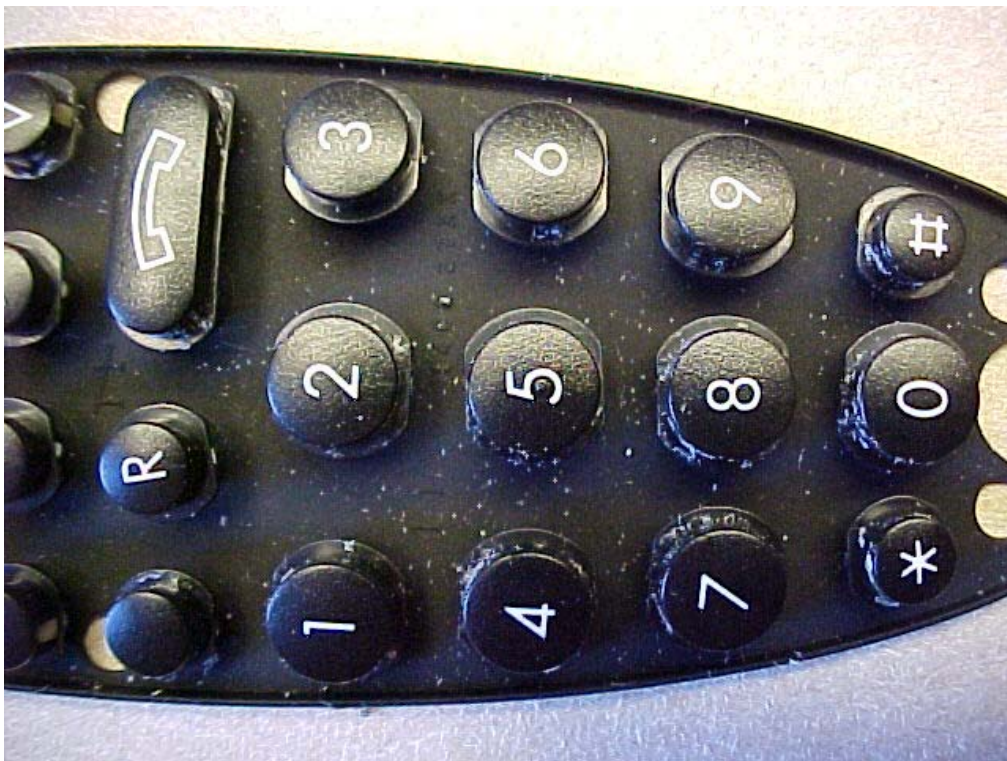
PHOTO 6. Small amount of salt deposits on keyboard membrane (external side).

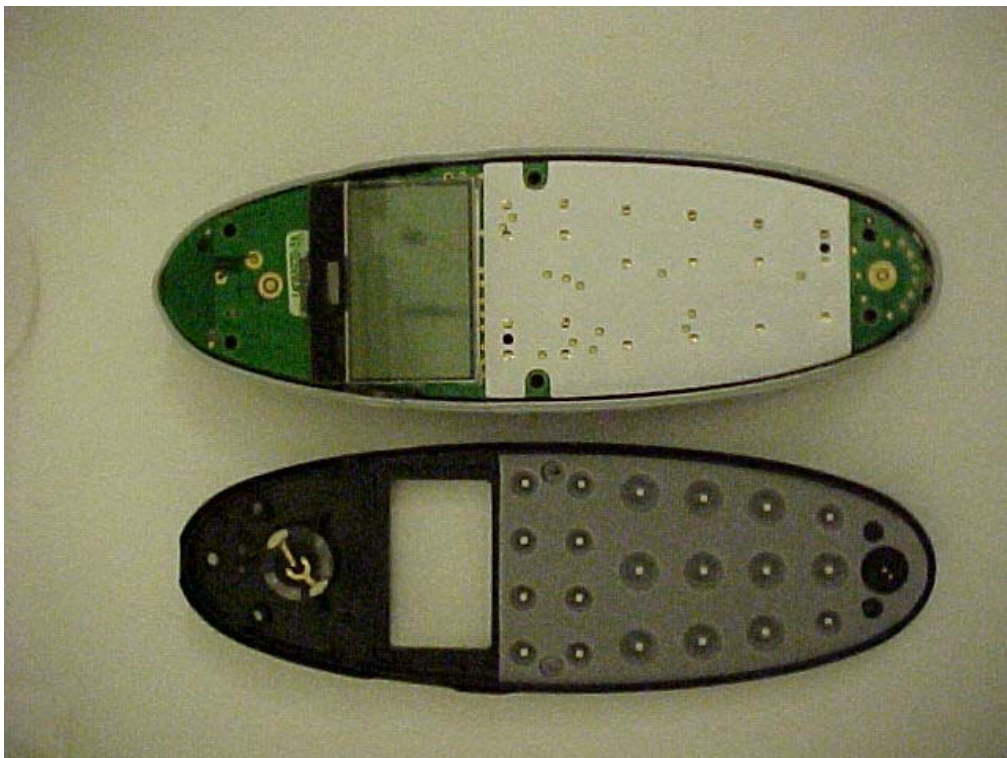
No water ingress was observed after the exposure.

PHOTO 8. Visual inspection after dripping (no water ingress observed).

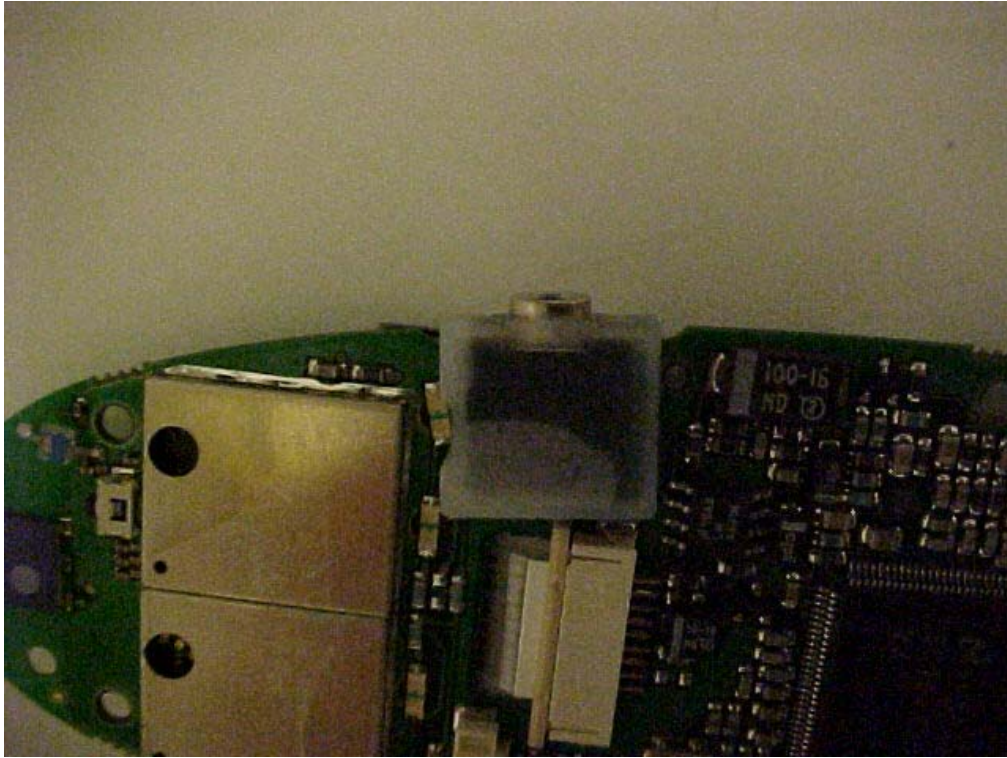
PHOTO 9. Water in sealed plug did not leak to the electronics.

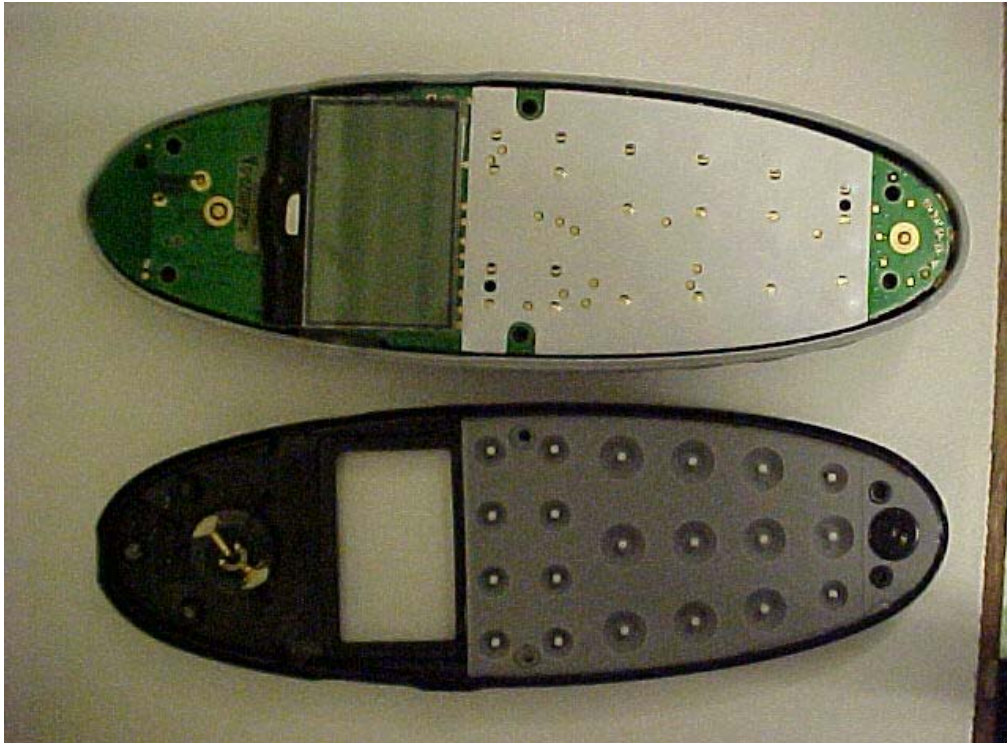
One drop of water was observed under the keyboard membrane after disassembling of the test specimen. However, it was concluded that this drop of water had passed the edge of the membrane during the disassembling. The exposure itself did not cause any water ingress.

PHOTO 11. Visual inspection after splashing (one drop observed under keyboard membrane).

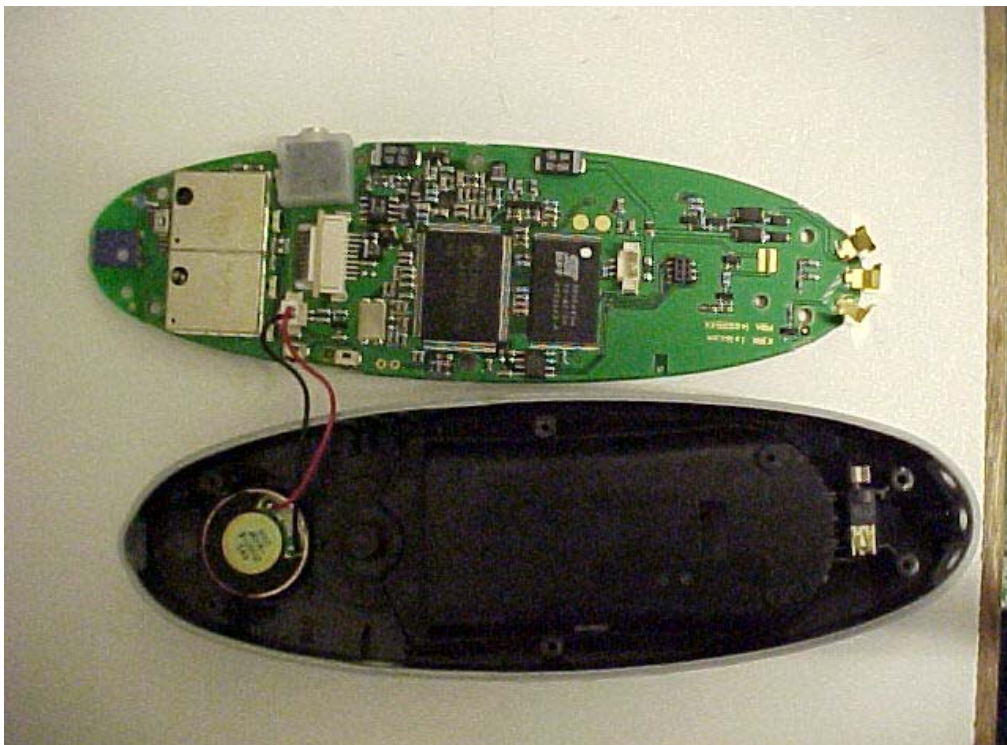
PHOTO 12. No water on the electronics and outside the sealed plug.

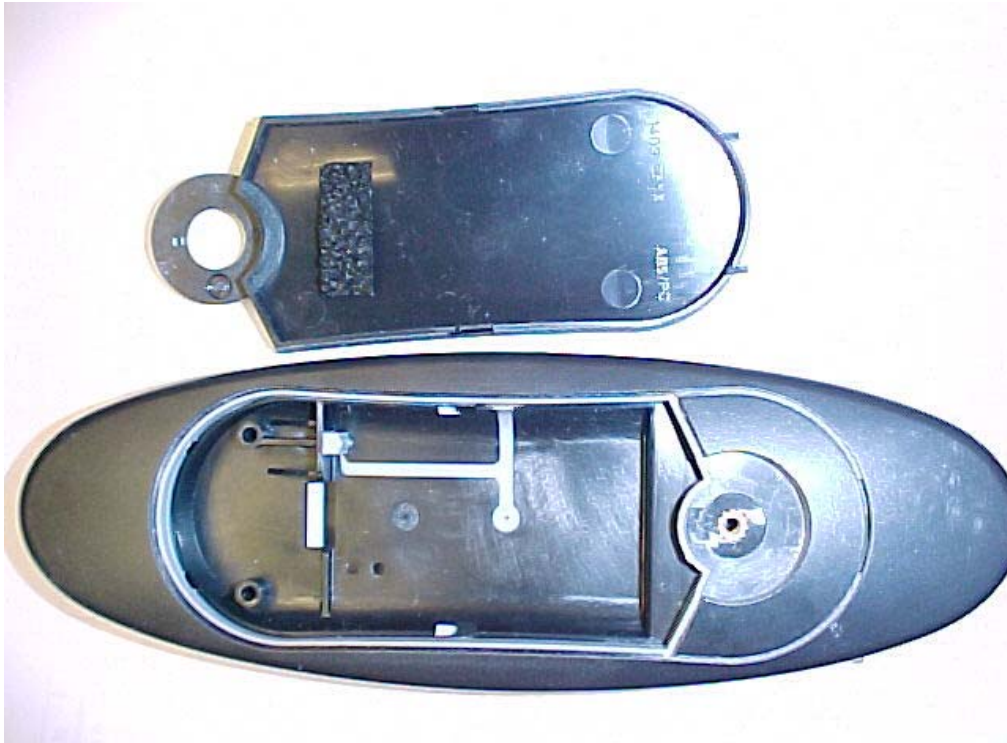
No dust deposit was observed inside the test specimen after the exposure.

PHOTO 13. Visual inspection after enclosure testing (dust-protected).

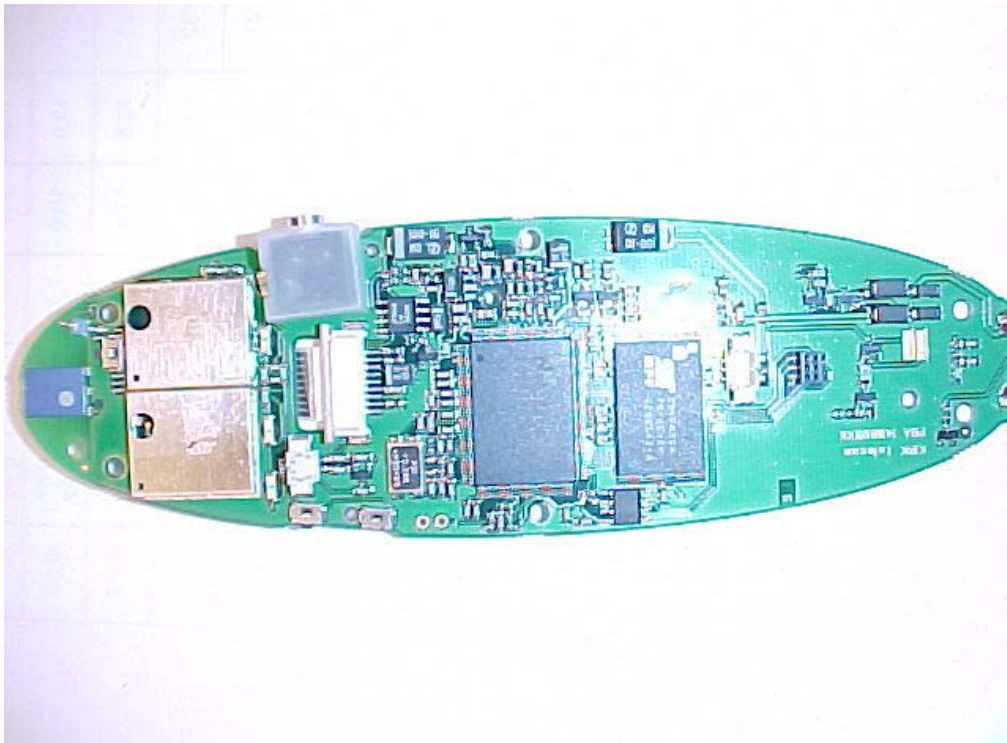
PHOTO 14. No dust deposits on electronics (rear side).

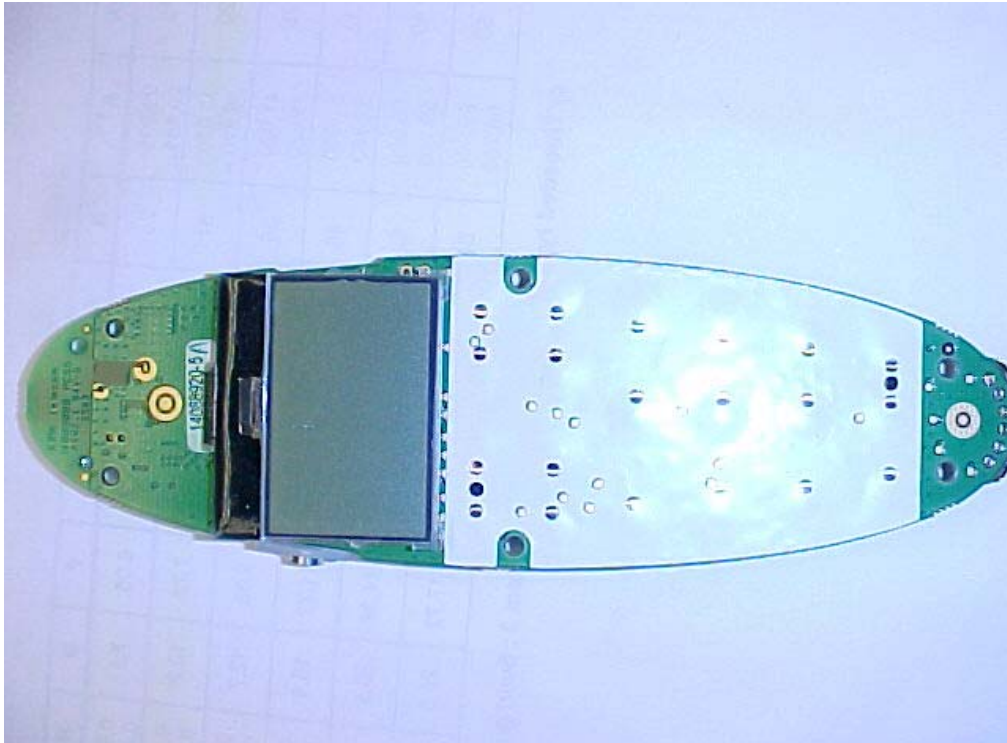
PHOTO 15. No dust deposits on electronics (front side).
